Итоги мониторинга «опасных» объектов

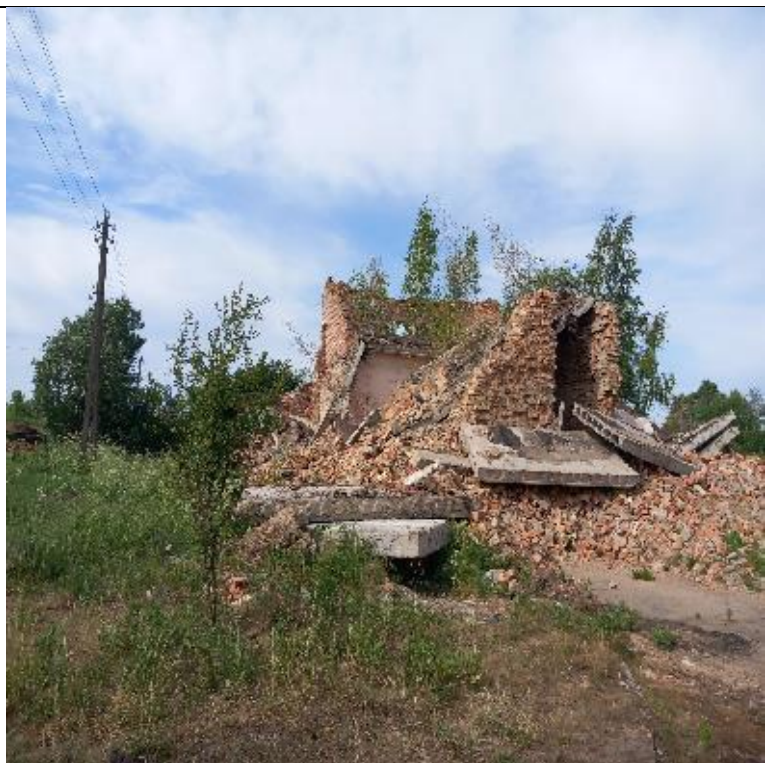
№ п/п	Выявленные недостатки	Наименование объекта	Фотоматериалы
1	<p>объект не функционирует, работы по сносу не завершены, отсутствует ограждение</p>	<p>банно-прачечный комплекс ОАО «Дуброво-2013»</p>

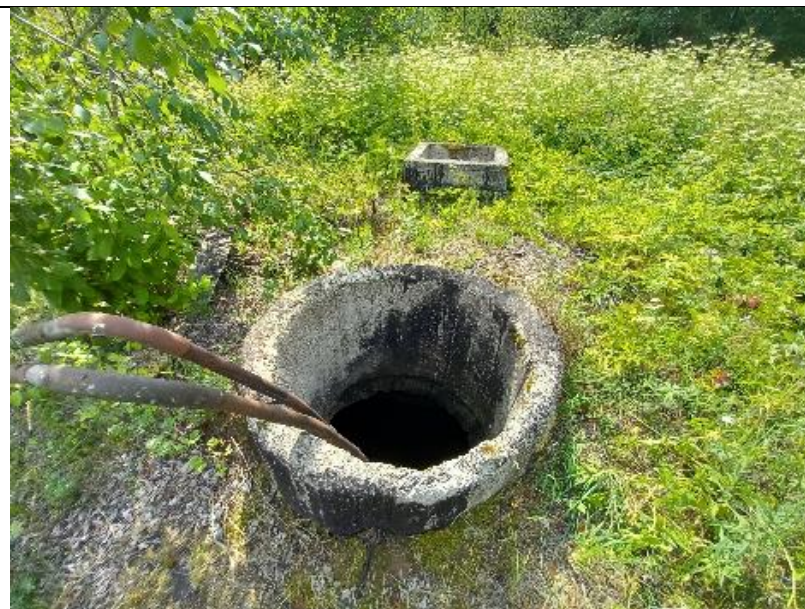
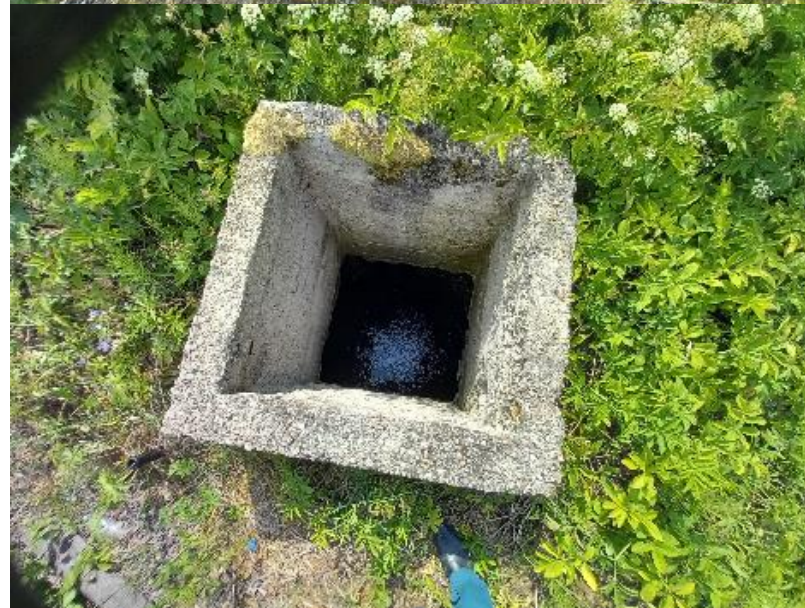
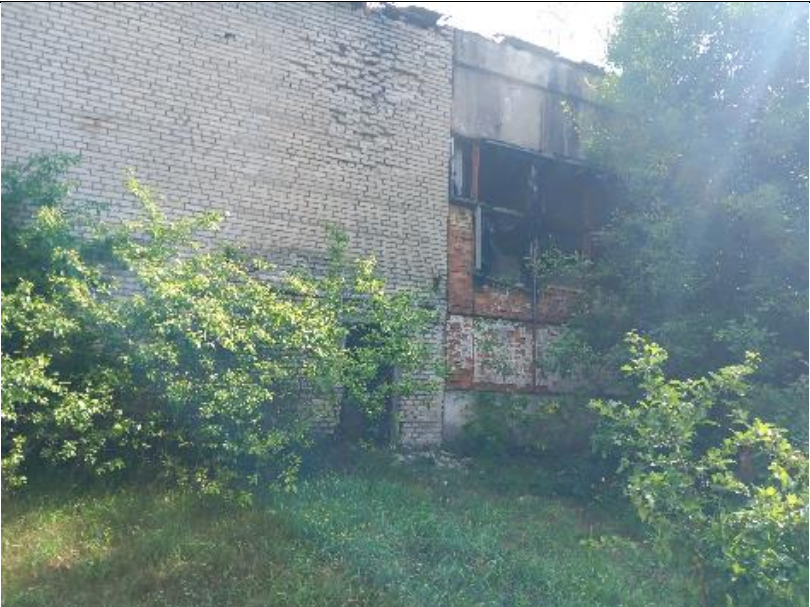
2

объект не функционирует, отсутствует ограничение доступа, люки технических колодцев не закрыты, подземный резервуар для хранения мазута не закрыт

территория и комплекс неэксплуатируемых зданий ООО «Интернэшнл Пластик» Олехновичский сельисполком д. Дуброво

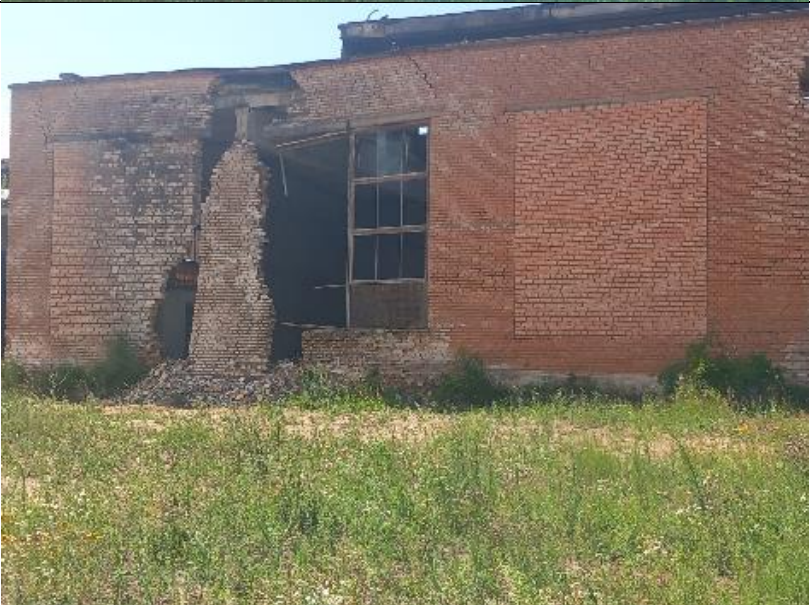
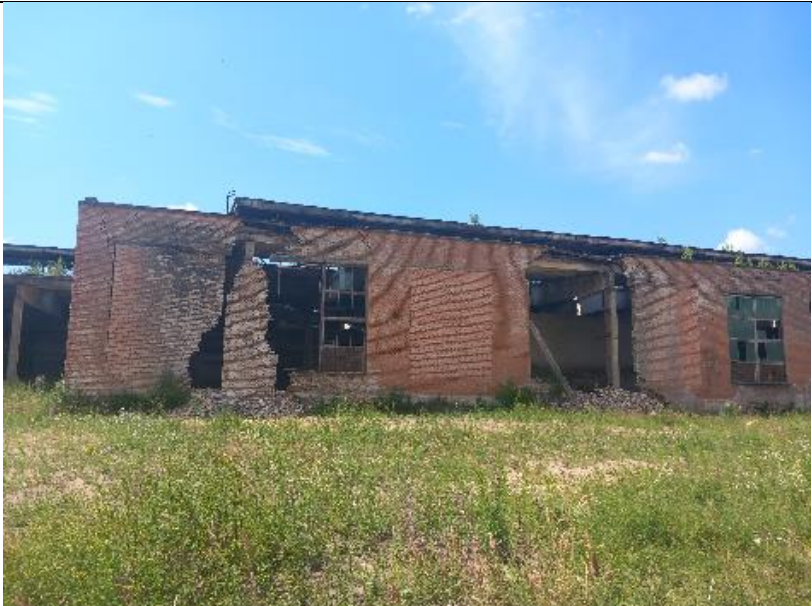
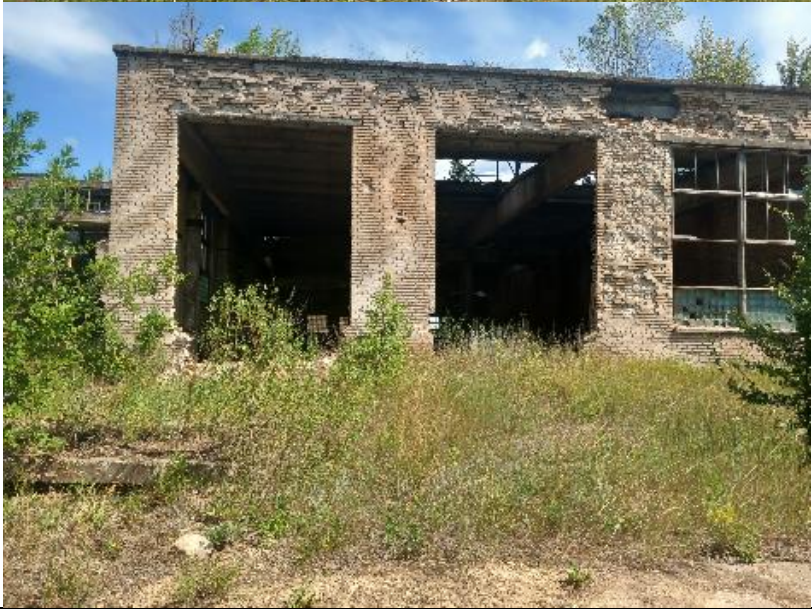
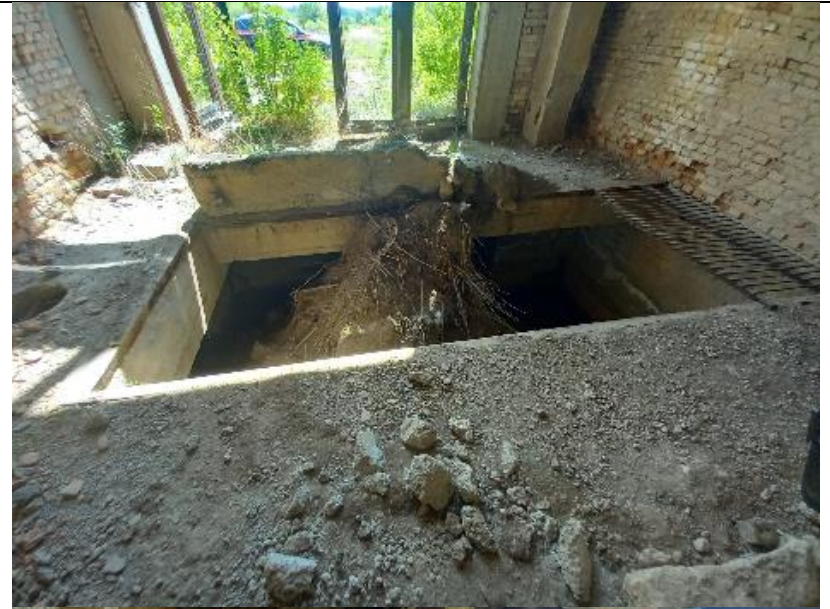
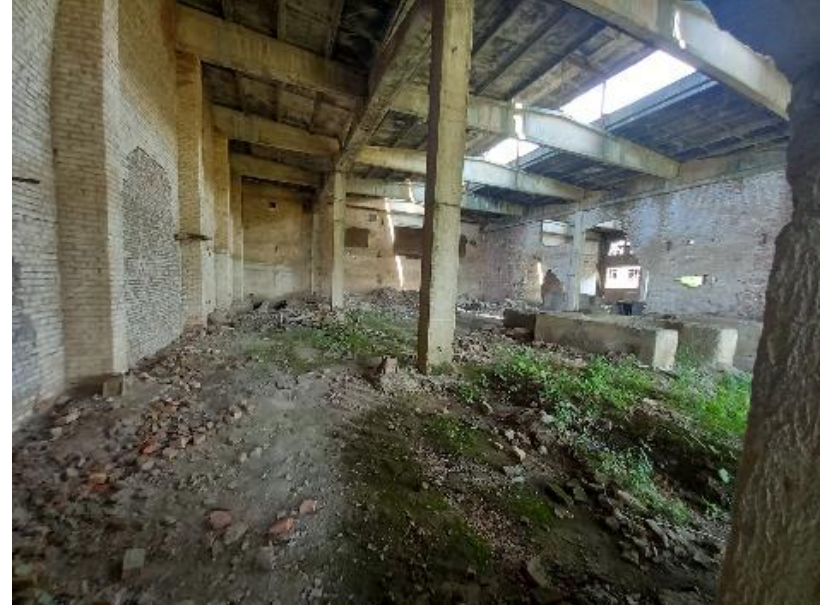
3	<p>объект не функционирует, не приняты меры по ограничению доступа, существует угроза обрушения строительных конструкций</p>	<p>Территория и комплекс зданий ООО «Скваер-плюс»</p>
